CIRCULAR NO.5-2023/MARITIME SAFETY

15 SEPTEMBER 2023

RADIOCOMMUNICATIONS EQUIPMENT ON BOARD SOLOMON ISLANDS REGISTERED VESSELS

WHAT ARE THE REQUIREMENTS FOR LOADING A VESSEL?

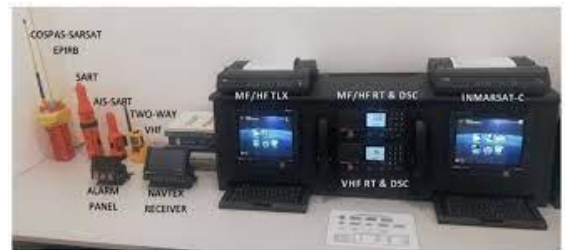
The Shipping (Non-Convention Vessel Safety) Regulations 2006 section 102(1) requires: *“Unless expressly specified by chapter IV of SOLAS 74 in relation to the Global Maritime Distress and Safety System (GMDSS) shall be carried by vessels of more than 300 gross tonnage and 24m and above”ⁱ*. For all other vessels, section 107 applies, and the required equipment are listed in a table consistent with the GMDSS areas proclaimed in the sea areas for which the vessel is certificated. In Solomon Islands, the area covered by VHF is very limited therefore all vessels must be fitted with radiocommunication equipment consistent with area A2.

SIMA reported to its Advisory Committee and technical working group that most of the vessels have dysfunctional or inoperative radiocommunication equipment, most of the vessels are not fitted with upgraded radiocommunication equipment compliant to GMDSS requirements and Digital Selective Call (DSC) system, most of the vessels need routine and regular maintenance of their radiocommunication equipment, and most of the vessels fails to report their position as required by the Regulations.

In this context, SIMA is now requesting vessels to be inspected by an appointed radiocommunication technician, to upgrade their radiocommunication equipment compliant to GMDSS and DSC prioritizing vessels of more than 500 gross tonnage and vessels carrying passengers.

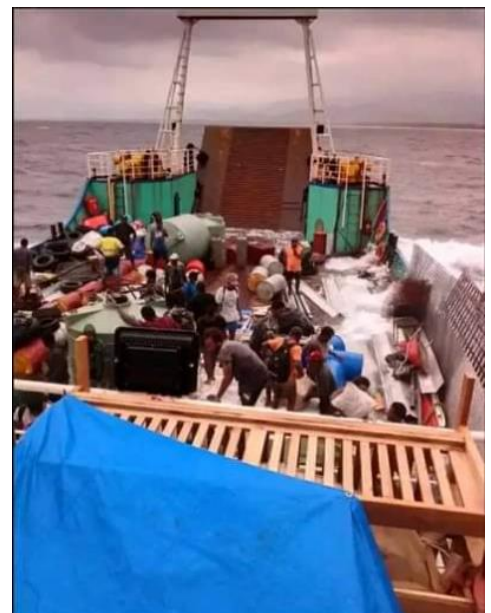
On 1 August 2023 in the evening, GULATATA'E 1 departed Honiara port for Southeast Malaita via Afio port. GULATATA'E 1 is a landing craft with a capacity of 334 passengers. The vessel departed Honiara with cargo on the cargo deck and more than 200 passengers. The vessel was not overloaded and had been inspected by SIMA just before departure.

On 2 August in the morning, the vessel passed Nudha Island and altered her course to Afio. As often in this area, the sea condition was tougher reducing the vessel's speed to 4 knots, the vessel heading headwind and waves hitting from 45° starboard. It is at that time that waves started to flood the cargo deck over the bulwark causing the unlash cargo of building materials to move and block the freeing ports preventing from seawater to discharge overboard. The accumulation of weight due to the soaked cargo, seawater on deck and water still in the vessel's ballast tanks caused a dangerous list on starboard which could have provoked the capsizing of the vessel and the loss of 200+ persons, cargo and vessel. The vessel was recovered from that situation when the master decided to throw the cargo overboard and alter the vessel courseⁱⁱ.

Director SIMA decided to cause a Preliminary Investigation under the Shipping Act 1998 as amended that identified the primary causes as the accumulation of seawater on the open deck due to freeing ports blocked by cargo loaded on deck, not lashed and shifting in bad weather. There are contributing factors to consider: i) the 300 bags of cements which are sensitive to water were not protected from seawater and were soaked by water increasing non-calculated weight; and ii) there was no proper supervision and verification of the loading and ballasting of the vessel ensuring proper stowage and lashing of deck cargo.

The Preliminary Investigation provided the Director with the following recommendations that will be implemented by SIMA:

1. Vessels to have on board a loading plan approved by SIMA that would include:
 - a. stowage and lashing of cargo as per design,
 - b. identification of persons responsible for loading, supervision and checking of cargo,
 - c. evidence of supervision and checks of cargo loading, stowage and lashing in shipboard records (logbooks, predeparture checklist, etc.),
 - d. protection of cargo from weather and sea conditions, and
 - e. Master to check for weather information before sailing.
2. Strengthen the Special (pre-departure) Inspections with more detailed verifications of presence of an approved loading plan, evidence of loading supervision and check, and appropriate stowage, lashing and protection of cargo.
